Rail Accident Report

Loss of brake control on a sleeper train approaching Edinburgh 1 August 2019

Report 05/2020
May 2020

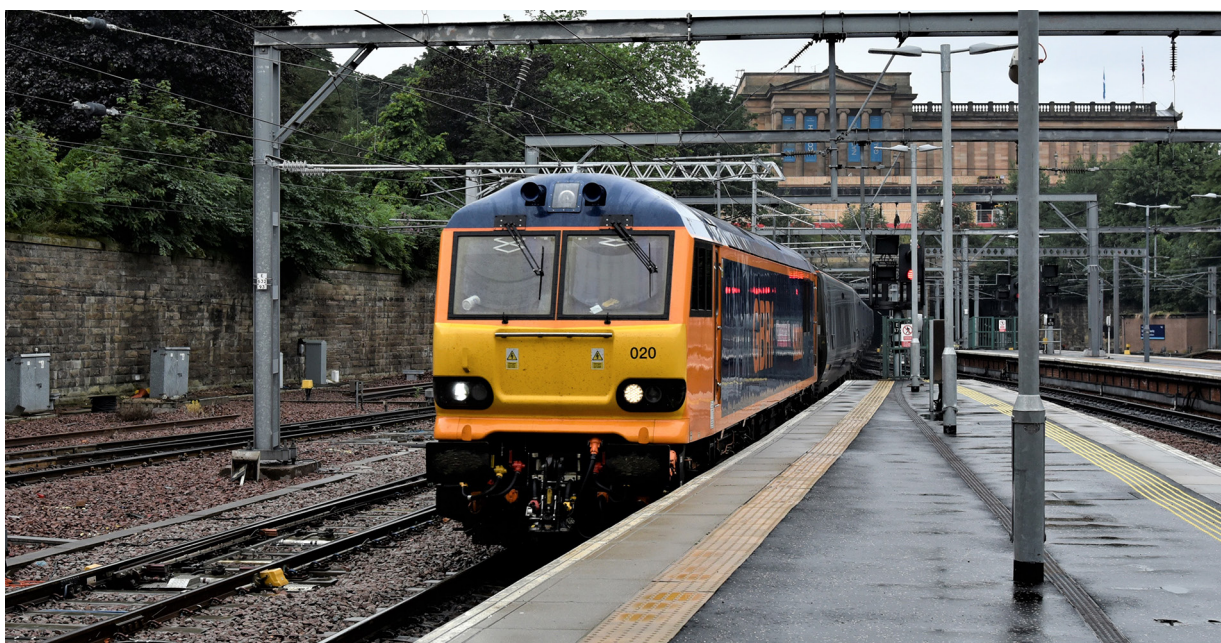
Figure 9: The train entering platform 11 during the incident (Courtesy of Peter Fitton)

- 46 The speed had reduced to 30 mph (48 km/h) by the time the train entered platform 11 (figure 9), and to 23 mph (37 km/h) by the time it passed the east end of platform 7. As the train was passing through platform 11, the train manager realised that there was a problem and operated the passenger alarm button in his office to try to stop the train. The passenger alarm button alerts the train driver to an emergency and applies the train brakes after a ten second delay (paragraph 29). When nothing seemed to be happening, because of the ten second delay, the train manager operated a second passenger alarm button in the passenger area outside his office, and he then felt the brakes apply sharply, bringing the train to a stop at 07:28 hrs. By this time the front of the train was in Calton South tunnel, with the rear between platform 7 and the tunnel (figure 10).

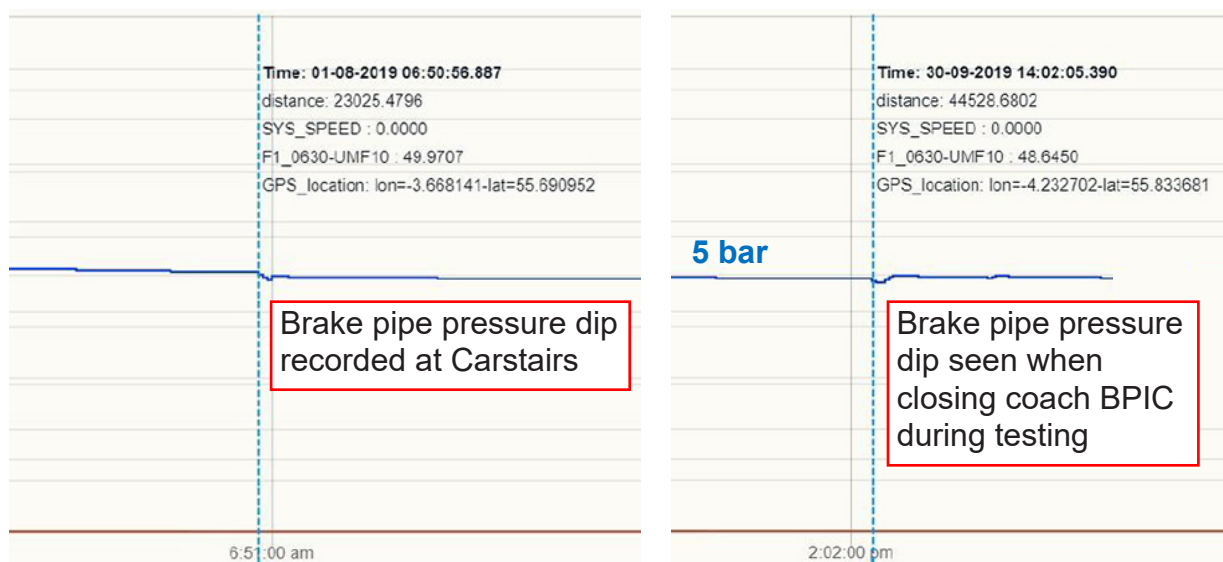
Figure 11: Comparison of brake pipe pressure dip at Carstairs and during BPIC operation testing

- 58 At 06:50:57 hrs, the locomotive's OTDR shows a small dip in the locomotive brake pipe pressure, which then recovers very quickly. This is consistent with the dip in pressure expected when the BPIC on the coach is closed, with that on the locomotive remaining open. The coaches' BPIC has a small vent on the non-coach side, which opens to atmosphere when the valve is in the closed position. The purpose of this is to release pressure in inter-vehicle connections ready for uncoupling.

- 59 The effect of closing only the coach BPIC was to seal 5 bar pressure in the brake pipe linking the coaches, and to vent the locomotive side. However, because the locomotive was still coupled with its BPIC open, the locomotive quickly detected the fall in brake pipe pressure and charged the brake pipe back to 5 bar. The rate of recharging was much faster than the vent could release the pressure, and so the brake pipe quickly returned to 5 bar. Figure 11 shows the brake pipe pressure record from the locomotive's OTDR, showing the short dip in the brake pipe pressure. It also shows a similar dip resulting from a post incident test operation of the coach BPIC at Polmadie depot. RAIB has concluded from this testing that it is almost certain that the brake pipe pressure dip seen at Carstairs indicates when the BPIC on the coach was closed.

- 60 The timing of the brake pipe pressure dip indicates that the BPIC was almost certainly operated part way through the period when both the driver and the shunter were struggling with the second ETS plug. This was at least one minute before they finally connected it and started to leave the track. This means that it is very unlikely that either the driver or the shunter operated the BPIC deliberately to provide some personal protection to prevent the train from moving when accessing the track, or to remove such protection when leaving the track. Neither the driver nor the shunter recall operating the BPIC when on track, and neither recalls seeing the other operate it. The absence of a reason to interact with the BPIC at the time indicated by the OTDR, combined with the lack of awareness of it being operated, leads RAIB to conclude that, although the possibility of it being turned by hand cannot be totally discounted, it was almost certainly operated inadvertently by either the shunter or the driver.

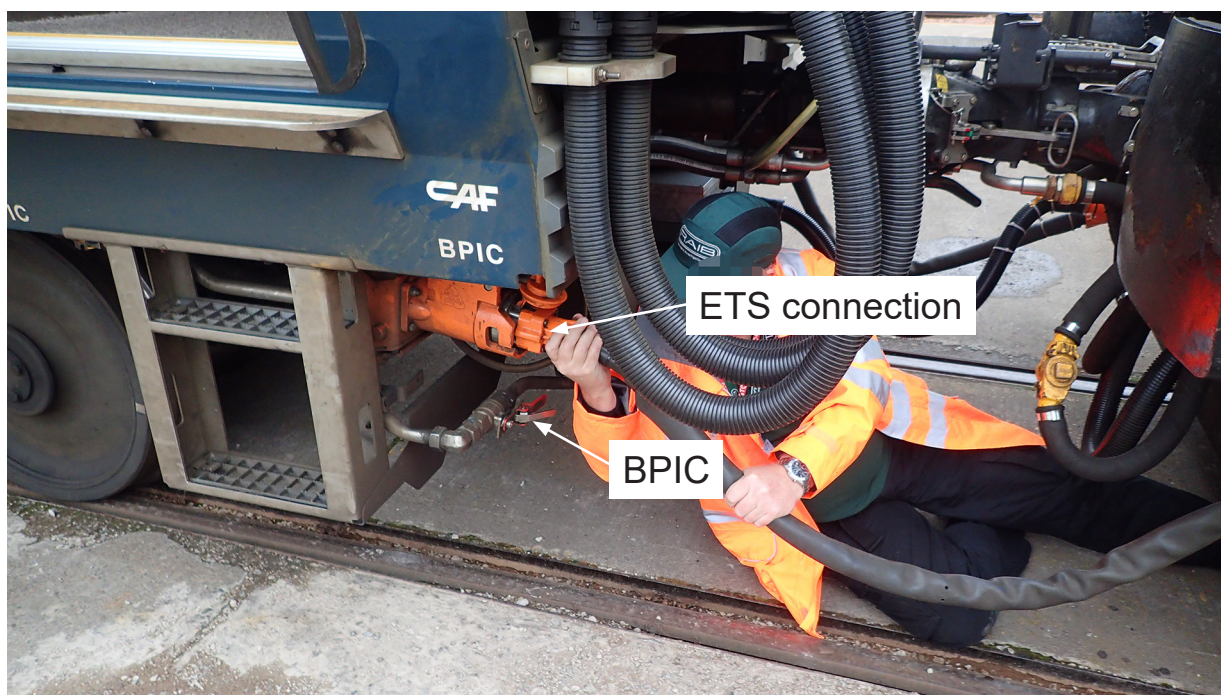
Figure 12: Location of the BPIC, showing proximity to ETS connection

- 66 When the shunter first went to help the driver, he was between the running rails, in a position similar to that shown in figure 12.⁶ The driver was attempting to connect the ETS plug while crouching outside the rails facing towards it, in a position similar to that recommended in the rolling stock ergonomic assessments. The shunter later moved out from between the rails to a position crouching beside the driver and close to the steps. The work with the ETS plug was being undertaken above and very close to the BPIC. It is very likely that the BPIC was either leaned on or brushed against by either the driver or the shunter, caught on clothing, or knocked by the loose ETS plug. Although the BPIC was open, it is possible that its handle might not have been turned sufficiently for the latch to have engaged prior to coupling the locomotive, thus making the valve more susceptible to inadvertent closure.

- 67 Venting through the closed BPIC would have been accompanied by the sound of escaping air. However, the vent on the coach BPIC is much smaller than that on the locomotive BPIC, and also smaller than that fitted to Mark 2 and 3 coaches, the previous vehicles used on the sleeper service. As a result, the Mark 5 BPIC vent makes much less noise than the staff would normally have experienced with other coaches and locomotives. Neither the driver nor the shunter recalled hearing the BPIC vent, over the sound of the adjacent locomotive, and so were not alerted to the BPIC being closed.

- 68 RAIB notes that, although a flying ballast protection plate is provided, this only protects the BPIC on one side and the valve's position means that it is exposed to impact from objects approaching from the other side, such as fallen vegetation or flying ballast. The handle and its latch appear to be less robust than the latched type handles normally used on UK rolling stock (figure 13), and therefore may be more susceptible to inadvertent operation. Latched BPIC handles were recommended by the Railway Inspectorate report on a collision at Darlington on 16 February 1977, which was caused by a BPIC being knocked closed by debris on the track.

- 2 *The intent of this recommendation is to reduce the probability of the driver losing control of the coach brakes on the Caledonian Sleeper trains.*

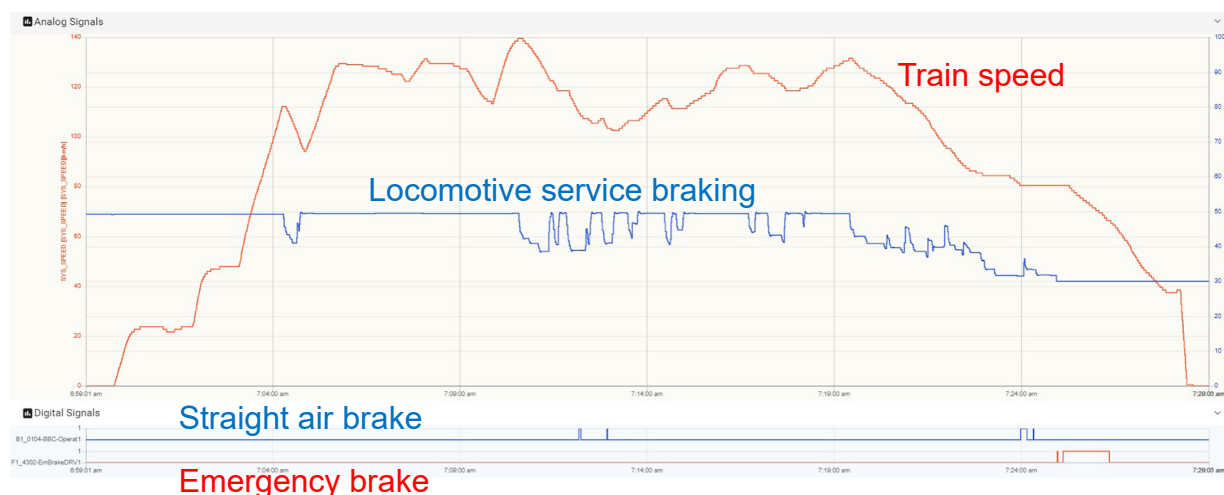
Figure 14: Speed and braking data from the locomotive OTDR

87 Figure 14 shows that the driver made two short applications of the locomotive's straight air brake during this initial period of service braking. Although this might suggest that the driver had some concern about his brakes, he stated that this was because the cab gauges were showing no brake cylinder pressure during braking, and he applied the straight air brake to get reassurance that the friction braking was working. The brake cylinder pressure gauges (paragraph 31) were not showing any friction brake application at the time because the rheostatic braking was providing the required braking. The driver allowed the train speed to rise after this, showing that he was not particularly concerned about the operation of the brakes.

88 At the overhead line neutral section near Curriehill station (paragraph 44), the main circuit breaker on the locomotive opened automatically as intended, but did not reclose, and the pantograph dropped about 25 seconds later. The OTDR data does not include the detail required to explain why this happened, or the detail of subsequent events within the locomotive's control system. However, it is likely that the locomotive's electrical converters shut down during this event, and consequently the rheostatic brake stopped working. That would have resulted in the locomotive's friction brake becoming active, thus continuing to retard the train.
