Rail Accident Report

Loss of brake control on a sleeper train approaching Edinburgh 1 August 2019

Report 05/2020
May 2020

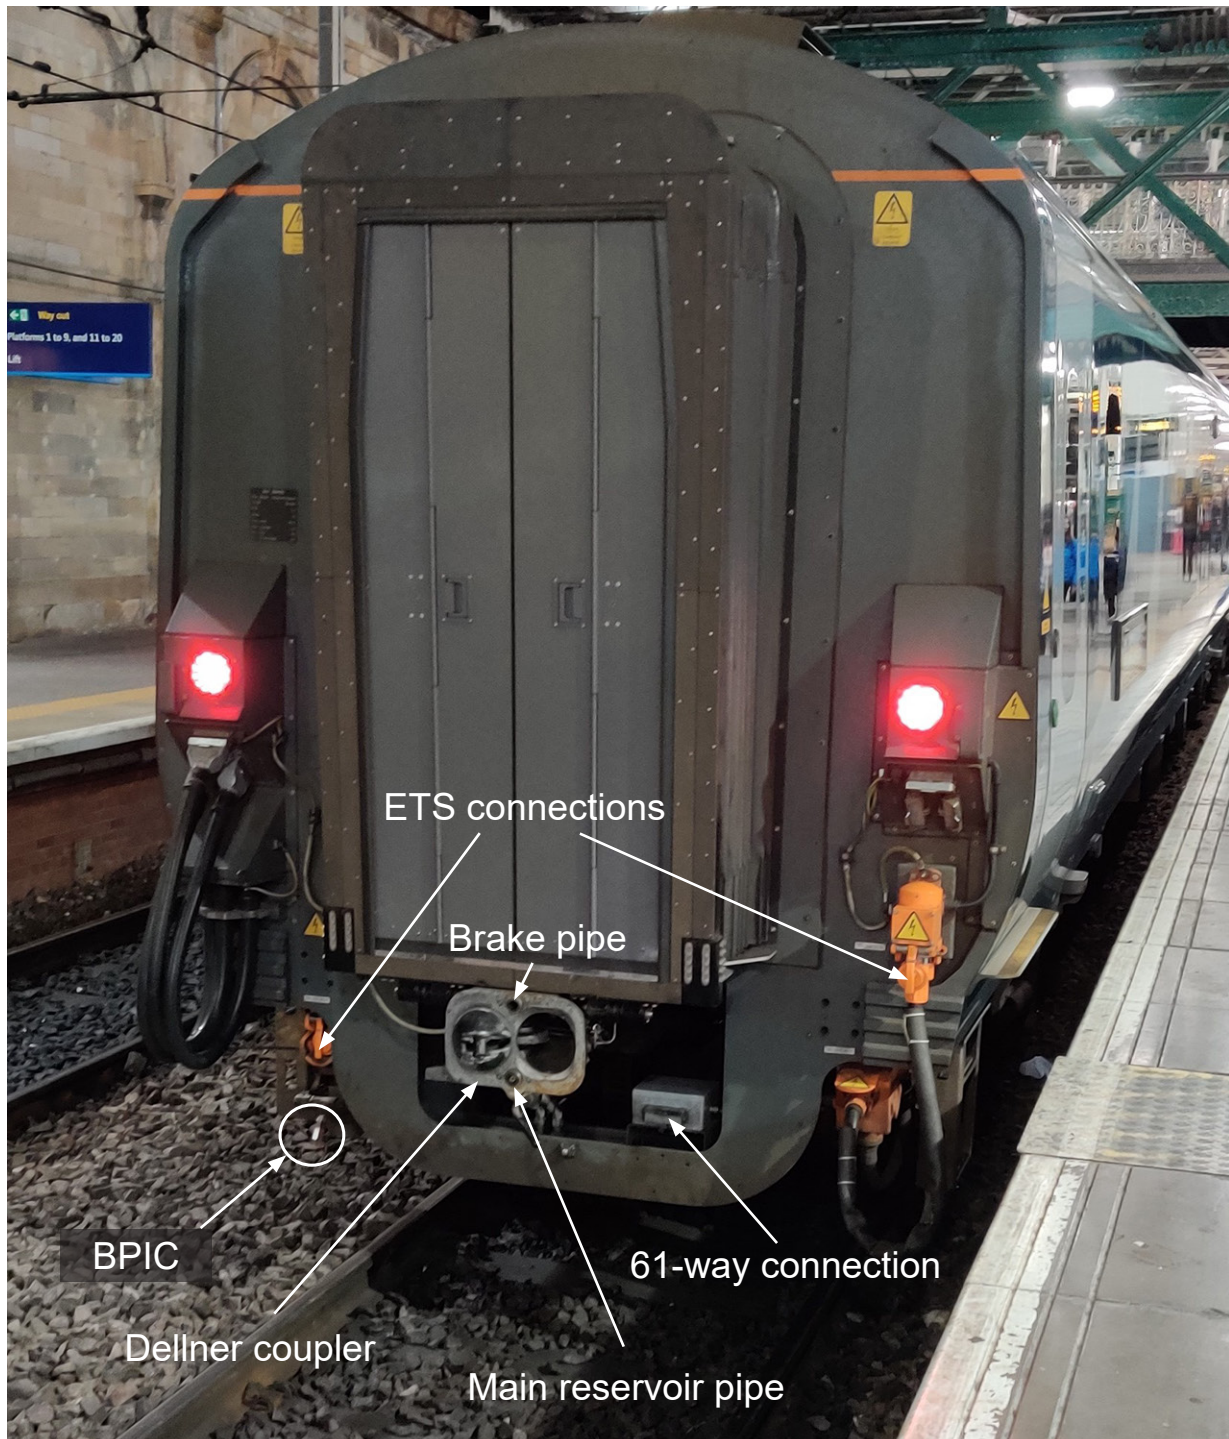
Figure 5: Mark 5 sleeper coach end, showing Dellner coupler and other connections

- 17 The coaches are coupled together, and to the locomotives, using a Dellner coupler, which incorporates both the mechanical and the pneumatic connections (figure 5). There are also two electric train supply (ETS) connections on each coach end, to provide power for heating, ventilation, lighting and other services. The two ETS connections to the first coach consist of a cable from the locomotive, fitted with a plug which fits into a receptacle on the coach, and a similar cable from the coach which fits into a receptacle mounted on the locomotive. There is also a 61-way connection for a detachable jumper cable to allow transmission of communications and data between the coaches and the locomotive. Between the coaches there are also several other control and communications connectors.

- 99 In October 2016 the BPIC was repositioned on the end of the coach underframe, due to the manufacturer's concerns about the possibility that the complexity of the brake pipe layout would result in excessive brake propagation⁸ times along a 16-coach train. The repositioned Mk5 BPIC was installed below the ETS socket (figures 5, 12 and 13). This change also required staff to access the track during coupling and uncoupling.

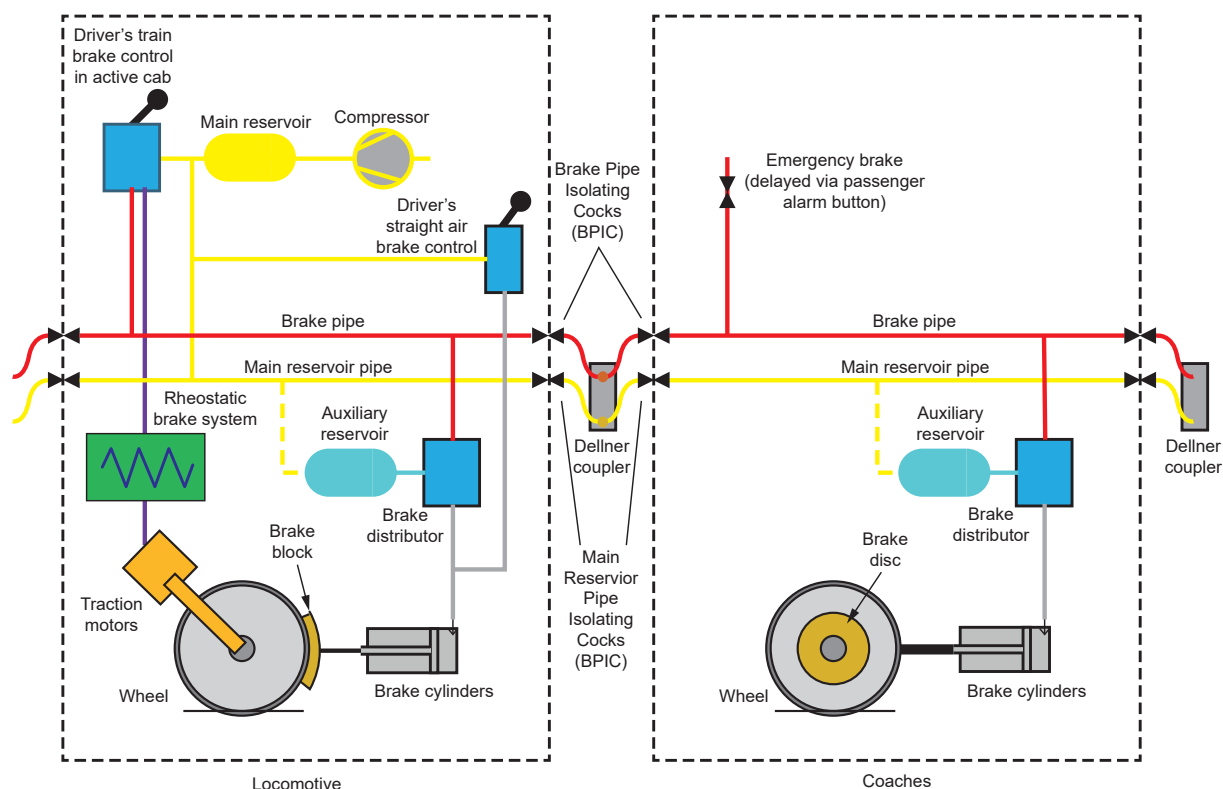
Figure 7: Simplified diagram of train brake systems (omitting other air-related systems)

- 27 Figure 7 shows a simplified diagram of the brake systems on the locomotive and the Mark 5 sleeper coaches. The locomotive controls the brakes on all the coaches using a conventional two pipe air system. A 'main reservoir pipe' and a 'brake pipe' run the length of the train, with the air connections passing through the couplers between each vehicle. Main reservoir and brake pipe isolating cocks (MRPIC and BPIC) are provided on the vehicle sides of every coupler. The main reservoir pipe keeps the auxiliary reservoirs on each vehicle topped up, using air from the locomotive main reservoir and compressor. The air in the auxiliary reservoirs provides the energy to apply the brakes on each vehicle. The driver's train brake control adjusts the air pressure in the brake pipe, with 5 bar pressure commanding brake release and a reduction from 5 bar commanding a proportionate brake application.

- 28 Each vehicle has a brake distributor that controls the flow of air from its own auxiliary reservoir to the brake cylinders on that vehicle when the brake pipe pressure falls below 5 bar. A reduction in the brake pipe pressure results in an increase in the pressure to the brake cylinders on all the vehicles, and thus the amount of friction braking applied. A brake pipe pressure reduction to 3.5 bar or lower causes a full application of the brakes on all vehicles. Gauges in the cab show the driver the air pressures in the brake pipe and the main reservoir pipe, as measured on the locomotive, and in the locomotive brake cylinders.
